Dredging Research Technical Notes

Stability Evaluation of the Octapod Sensor Mount

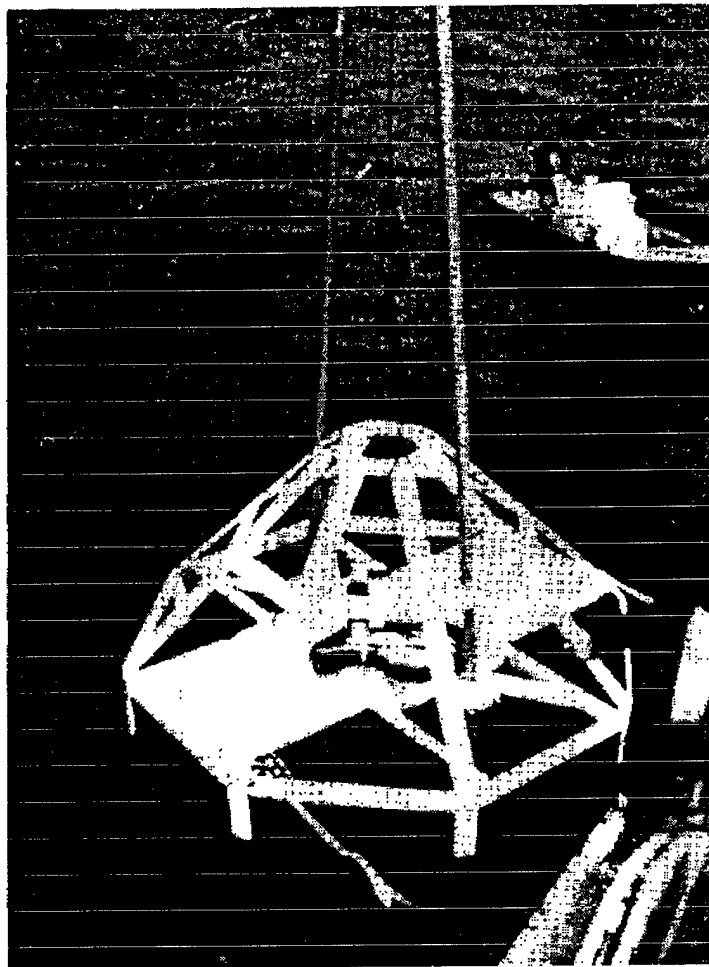
Figure 1. OCTAPOD being deployed

The Octapod (Figure 1) is a 4-ft-tall, eight-sided, heavy steel instrument mount designed by CERC's Prototype Measurement and Analysis Branch (PMAB) to support and protect a variety of oceanographic sensors. The 1-ft-long leg extensions located at each of the eight corners were designed to bury into the bottom to prevent trawler nets from snagging the base plate and entangling the Octapod. Although the design of the Octapod used in this field evaluation has recently been extensively modified to make it more trawler-resistant, the stability results presented herein are still valid.

The modified design is six-sided and 2 to 3 ft tall, depending on application, with 2-ft-long leg extensions.

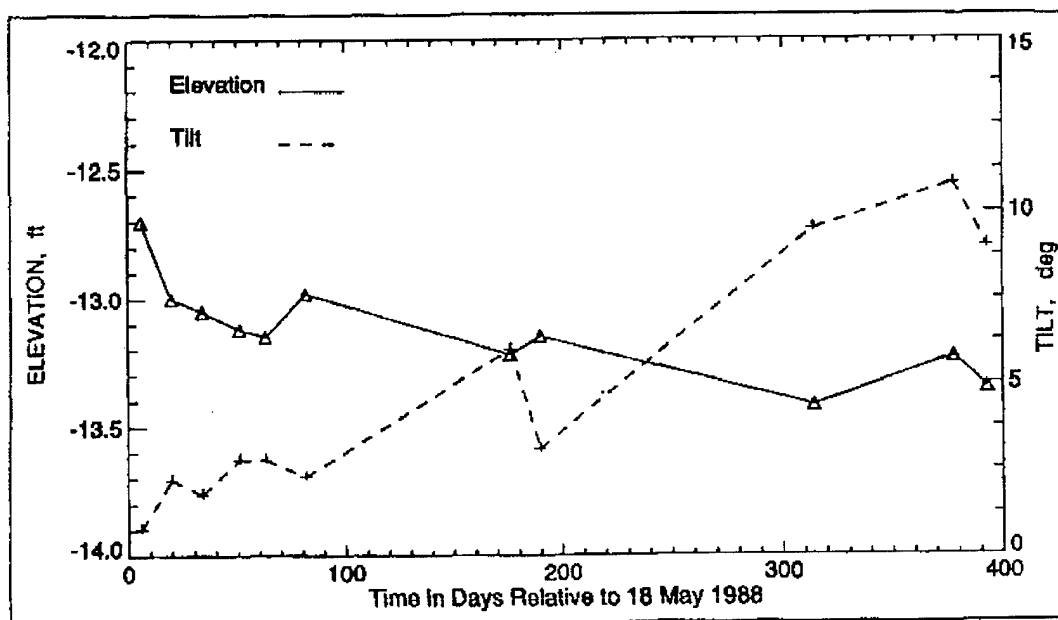
Figure 2. Octapod elevation and tilt

Eleven measurements were made starting on 24 May 1988 (day 6 on the abscissa of Figure 2) and ending on 15 June 1989 (day 394). The measurements were not uniformly distributed through time; over half were taken during the first three months of the study when the greatest amount of settling was expected. Some additional measurements were attempted but could not be made because of high seas. In addition to the measurements of the Octapod, 24 surveys were conducted of profile line 188 located 80 ft to the south. Five of these surveys are shown in Figure 3. Table 2 lists interpolated depths at the position of the Octapod (1,570 ft) and at other nearby locations. Periodic diver inspections were made to observe the Octapod and note any scour or filling that took place.

Table 1 summarizes each of the Octapod measurements. Elevations computed based on each of the prisms compared favorably. Note that the adjusted X and Y coordinates given in Table 1 are for the location of the prisms, not of the Octapod itself. A detailed analysis of the 10 repetitions from each measurement session indicated that by using 10 measurements the tilt of the Octapod could be resolved to 1 deg and the elevation could be resolved to 0.1 ft. The variation in Octapod elevation and tilt are shown in Figure 2. Figure 2 clearly shows the rapid decrease in depth (0.3 ft) which occurred immediately following the first survey, an apparent response to the installation. It also shows the relative stability during

most of the period and the points that indicate upward movement of the Octapod.

The most significant of these upward movements occurred during August when it "rose" 0.2 ft. This occurred during a survey that also shows a general upward movement of the entire profile of about 0.2 ft. Since there were no storm events, this apparently is an error which probably resulted from a slight tilt of the Elta 2S (0.0044 deg). The first survey in November is also suspect. It is 0.1 ft below the 24 November 1988 survey (day 191), and the 20 July (day 64) survey; the value for the tilt is much greater than for those other surveys.

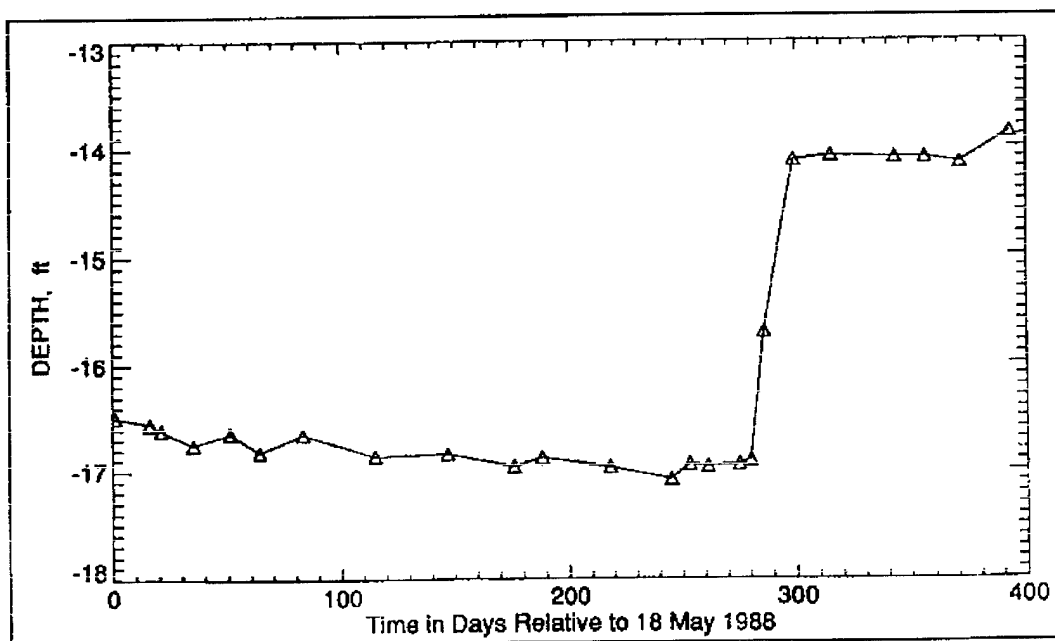
Figure 4. Variation in depth at the Octapod site

The variations in sea-floor depth at the Octapod are clearly seen in Figure 4 which plots the data in Table 2. The figure shows that at the location of the Octapod the bottom was extremely stable until a sequence of

two storms occurred, the first on 24 February 1989 (day 282) and the second two weeks later on 7 March (day 296). Each of these storms moved significant amounts of material offshore, ultimately covering the Octapod with 2.7 ft of sediment.
